BULLETIN 81

ENVIRONMENTAL GEOLOGY
of
LINCOLN COUNTY, OREGON

STATE OF OREGON
DEPARTMENT OF GEOLOGY AND MINERAL INDUSTRIES
R. E. CORCORAN, STATE GEOLOGIST

1973

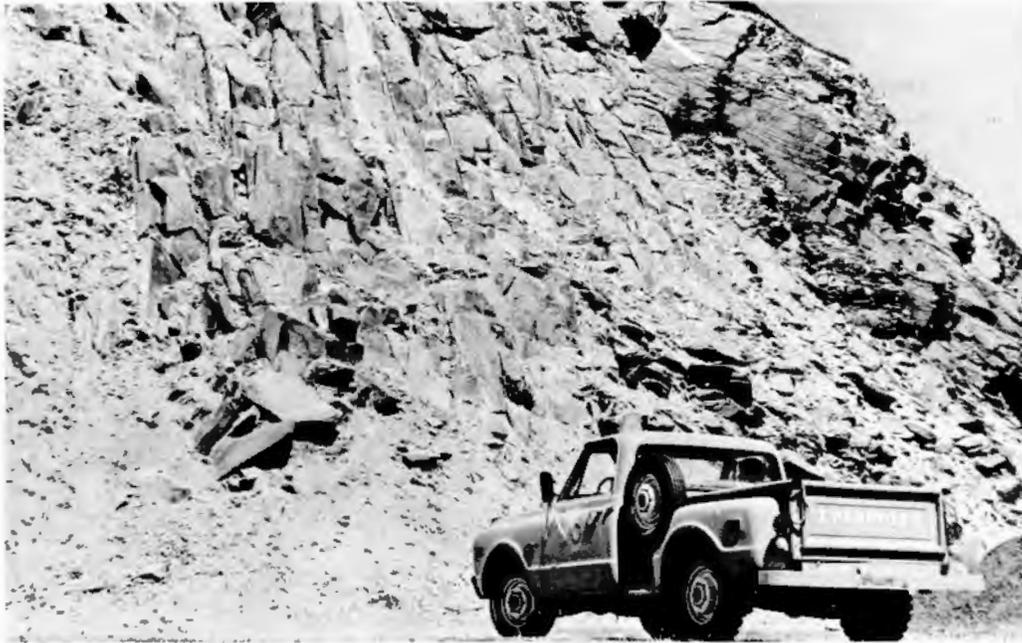
Photo 21. Nepheline syenite at Blodgett Peak (quarry No. 57) formerly quarried for construction of Newport jetty.

Nepheline syenite at Table Mountain and at Blodgett Peak would appear to be suitable for jettystone, and in fact that from Blodgett Peak had been used on the Yaquina Bay jetty. The rock on Table Mountain has exceptionally wide jointing, and proper quarrying should produce the sizes needed for jetty construction and in sufficient amount to be economical; should future jetty work be required at Yaquina Bay, this stone should be considered as a possible local source of rock. Since most contracts involve several million tons of rock at prices approaching \$15 a ton in today's market, use of local rock should reduce costs and be good for the economy of the County. Most recent work on the jetty utilized rock from the Calkins quarry on Cedar Creek in the Siletz River drainage.

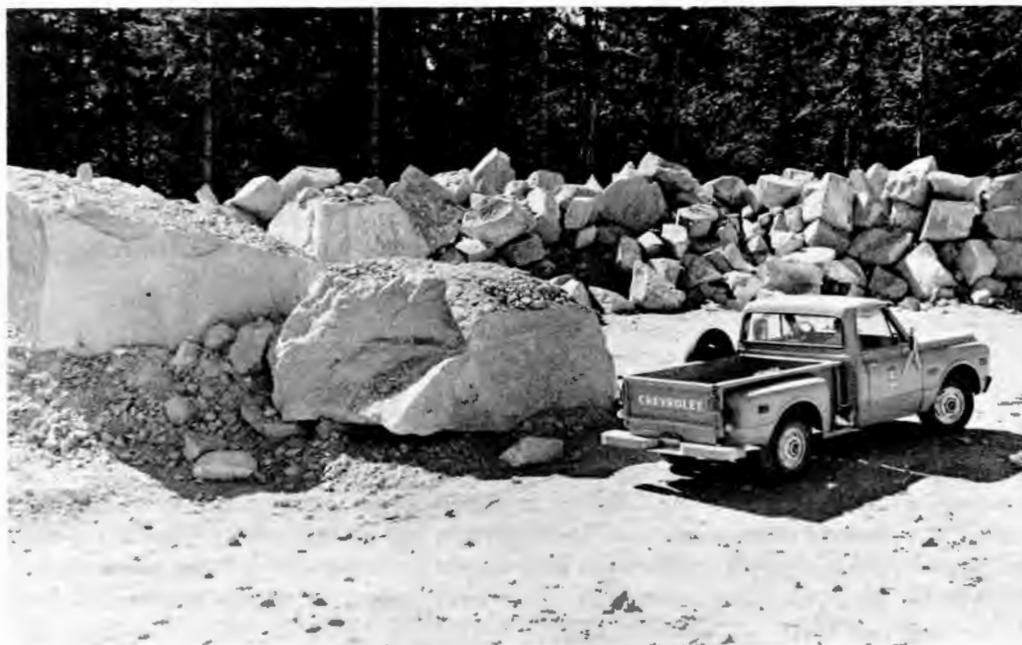
Photo 22. Thick sill of nepheline syenite on Table Mountain produces large blocks of rock (quarry No. 49).

Nepheline syenite, a somewhat rare type of igneous rock, occurs in Lincoln County at Table Mountain and at Blodgett Peak. The Table Mountain rock is 300 feet thick, covers about 1 square mile, and has little overburden. It is estimated to contain 700 million tons of recoverable syenite.
